Erosion along Unformed Roads, Tracks, Firebreaks and Fencelines in Eastern Cape York Peninsula and Best Management Practices (BMPs) for Erosion Control

Produced by
Cape York Water Partnership (CYWP)

Shellberg, J., Albert-Mitchell, O., Klye, D., Smith, B., 2024. *Erosion along Unformed Roads, Tracks, Firebreaks and Fencelines in Eastern Cape York Peninsula and Best Management Practices (BMPs) for Erosion Control, Version 1.3*. Produced by the Cape York Water Partnership (CYWP) with funding from the Great Barrier Reef Foundation (GBRF) & Reef Trust Partnership (RTP). <https://www.capeyorkwaterpartnership.org/>

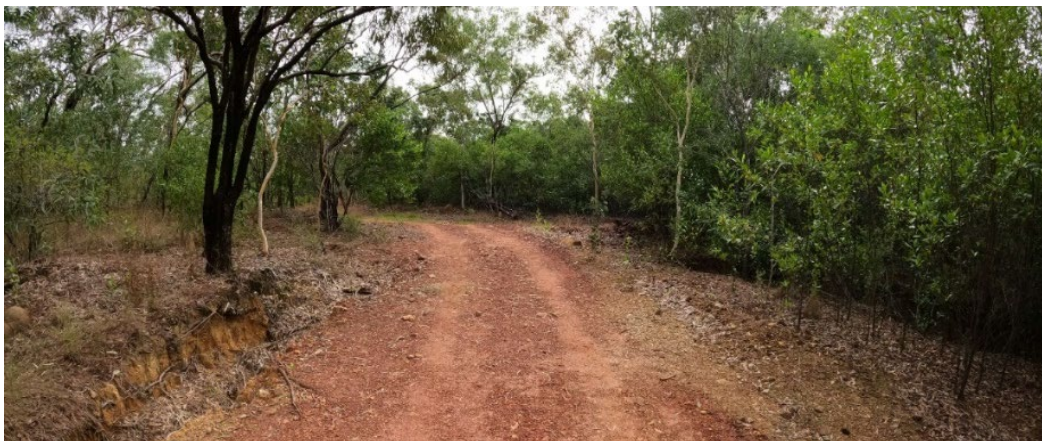
Figure 1 An example of an unformed primitive road in Eastern Cape York Peninsula.

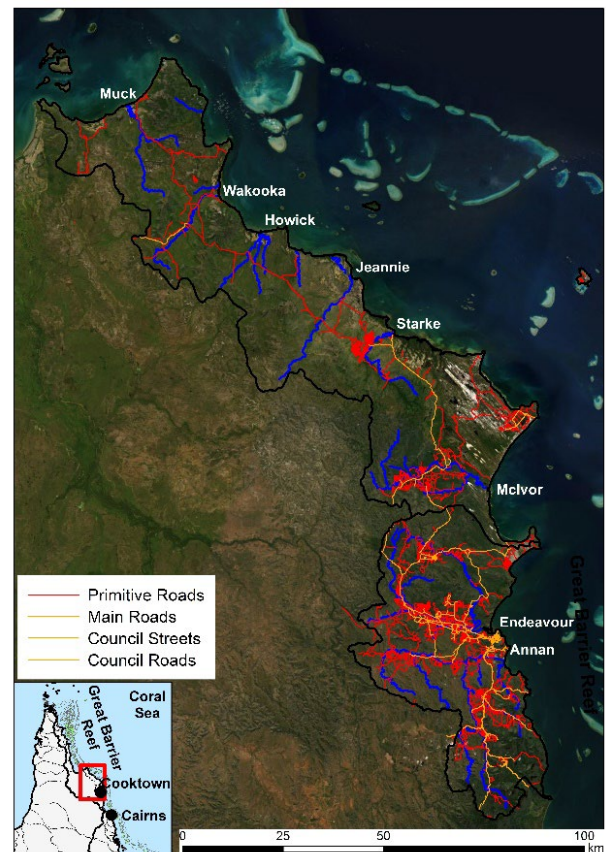
Figure 2 Primitive Roads in Coastal SE CYP

In southeastern CYP (Figure 2) (Annan, Endeavour, Mclvor, Starke, Jeannie, Muck), there are 4100 km of roads, tracks, and fencelines mapped and targeted for ground surveys and erosion control prioritisation. The majority of linear disturbances in this area are primitive dirt tracks (2539 km, 62%), fencelines (887 km 22%), and Council Streets and Roads (556 km, 14%) (Figure 2).

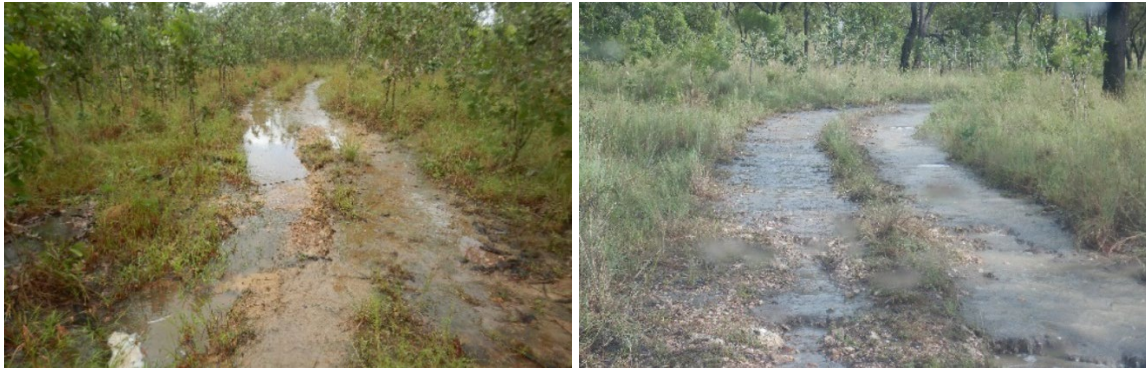
Figure 3 Typical primitive road (2-wheel dirt track) on CYP with intercepted water flow in the wet season.

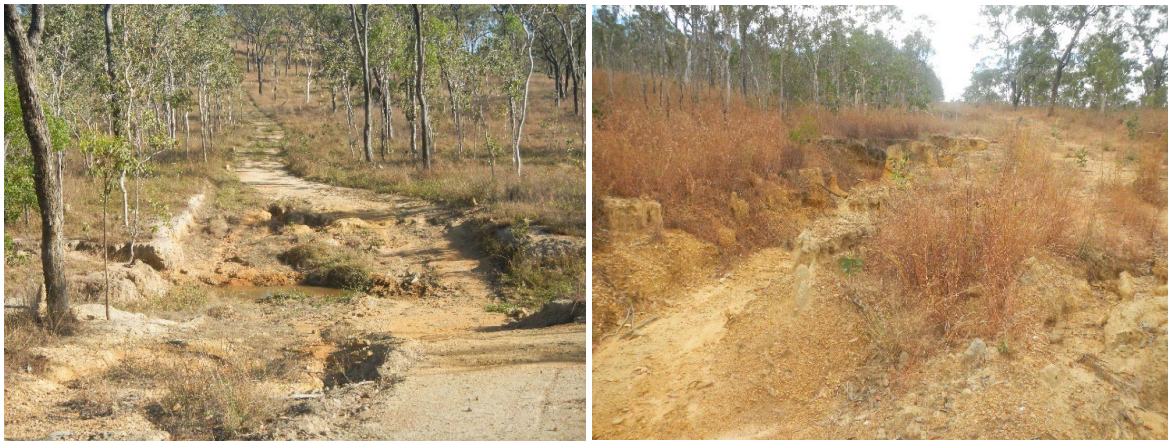
Figure 4 Typical primitive road gully erosion issues at small creek and hollow crossings.

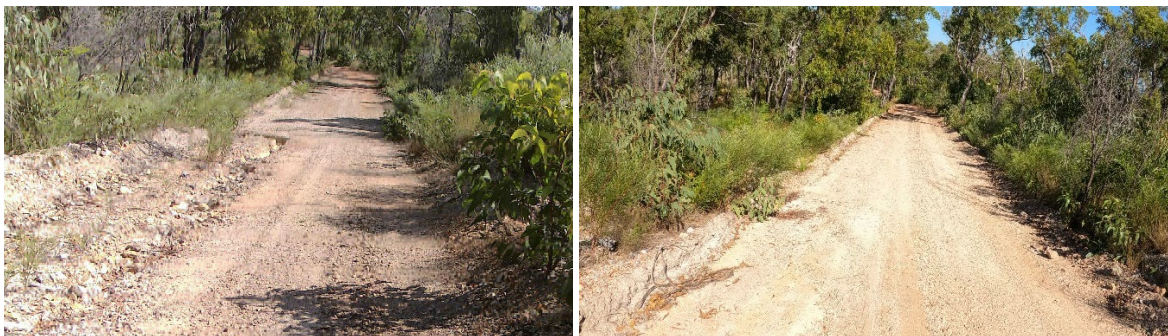
Figure 5 Annual grading before (left, June 2022) and after (right July 2022) track preparations for firebreak access, repeatably filling in erosion holes to be re-eroded the next year in the same location.

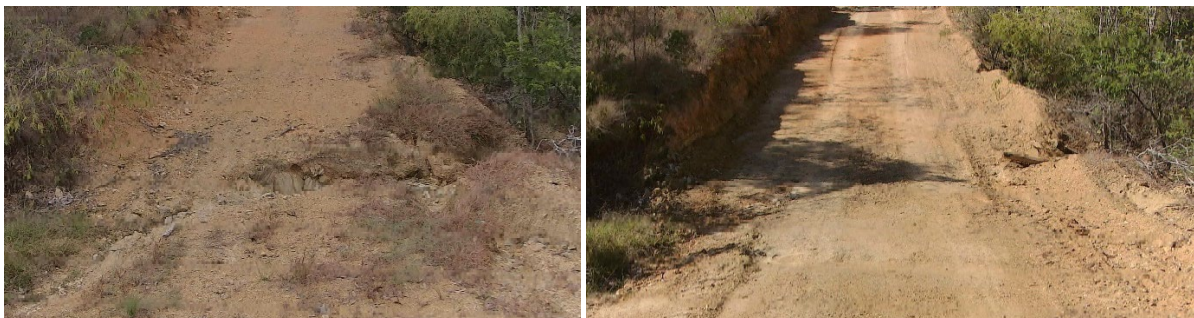
Figure 6 Annual grading before (left, June 2022) and after (right July 2022) track preparations for firebreak access. The cycle continues of erosion, re-grading for access, and re-erosion the next wet season.

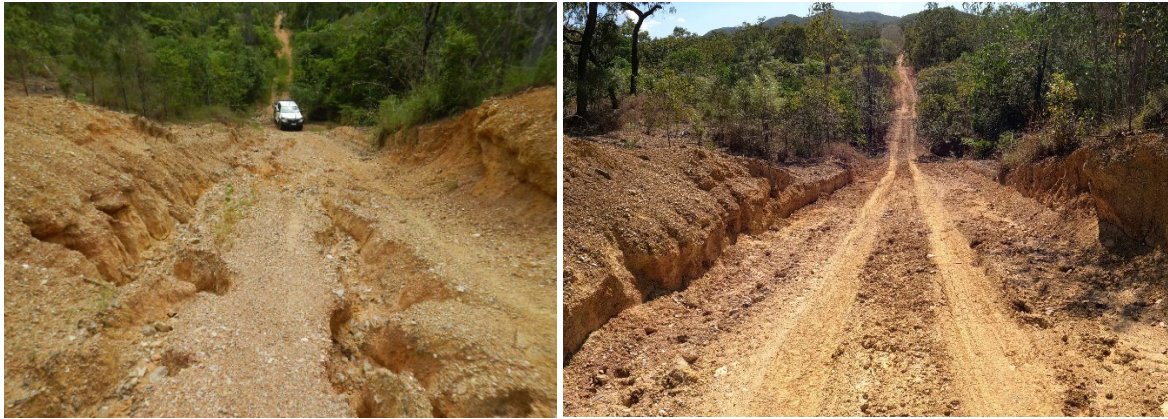
Figure 7 Annual grading before (left, June 2022) and after (right July 2022) track preparations for firebreak access. The cycle continues of erosion, re-grading for access, and re-erosion the next wet season.

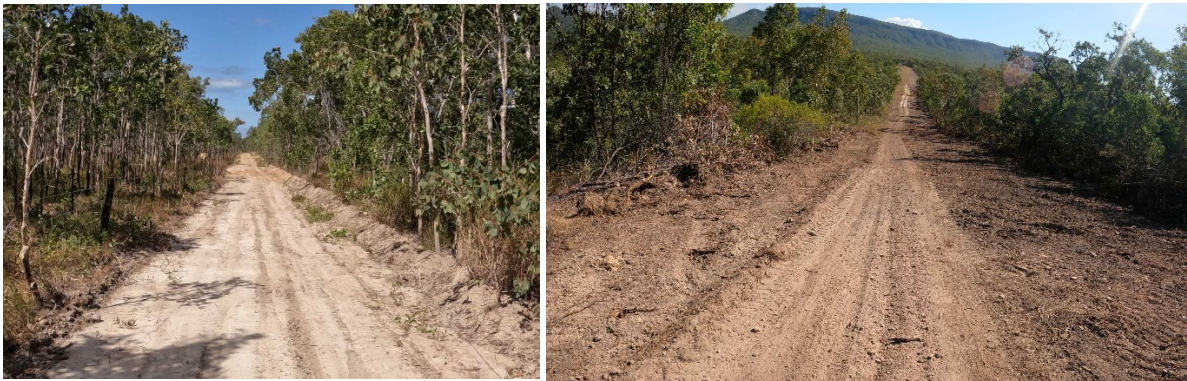
Figure 8 Typical annual grading along a fenceline that will accelerate wet season sheet and shallow rill erosion.

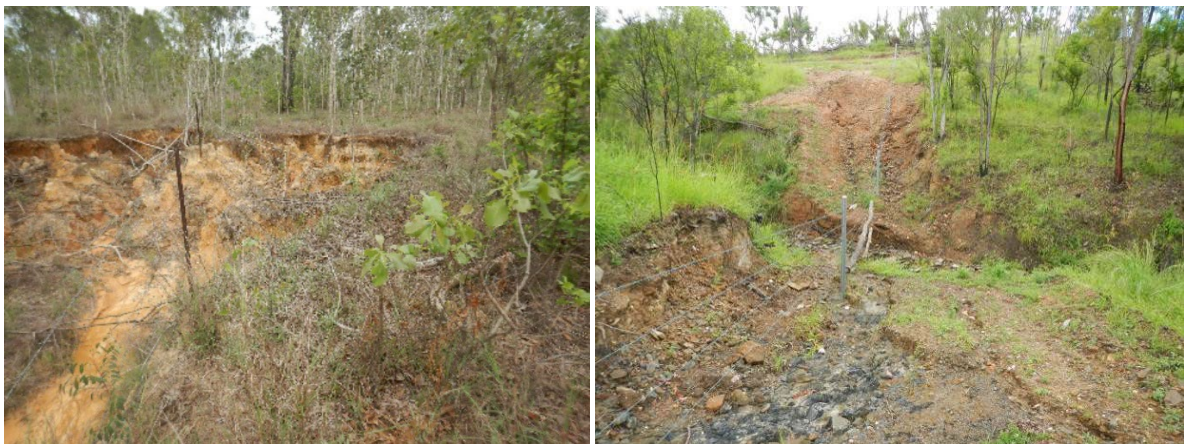
Figure 9 Examples of fenceline erosion problems, such as gullying and rilling due to fenceline machine disturbance.

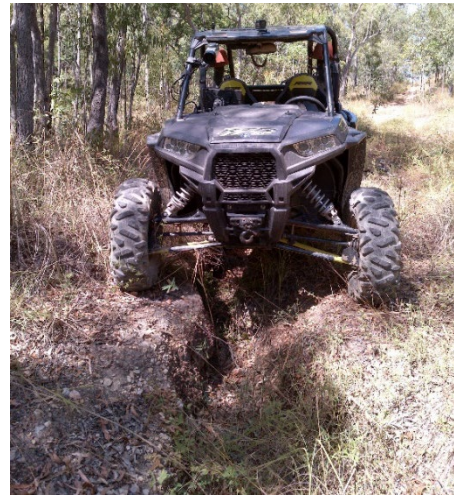
Figure 10 The majority of primitive road erosion surveys were conducted by 4x4 buggy.

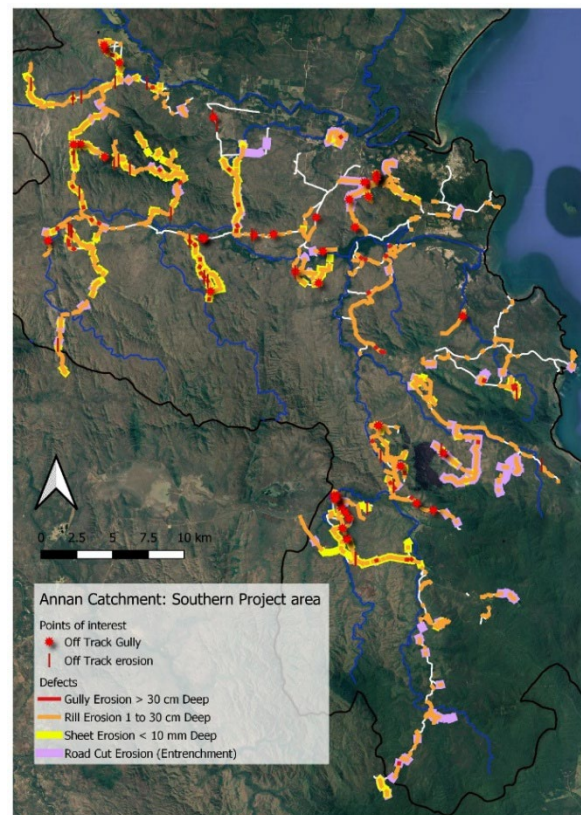
Figure 11 Erosion defect mapping in the Annan catchment.

In 2022-2024, over 2800 km of roads, tracks, and fencelines were surveyed, and over 1280 km of unique primitive roads were mapped. Hundreds of thousands of georeferenced photos (one every 5 m) were collected and processed through an erosion defect software system and data dictionary. Erosion defects maps were created for specific sub-catchments and properties (Figure 11).

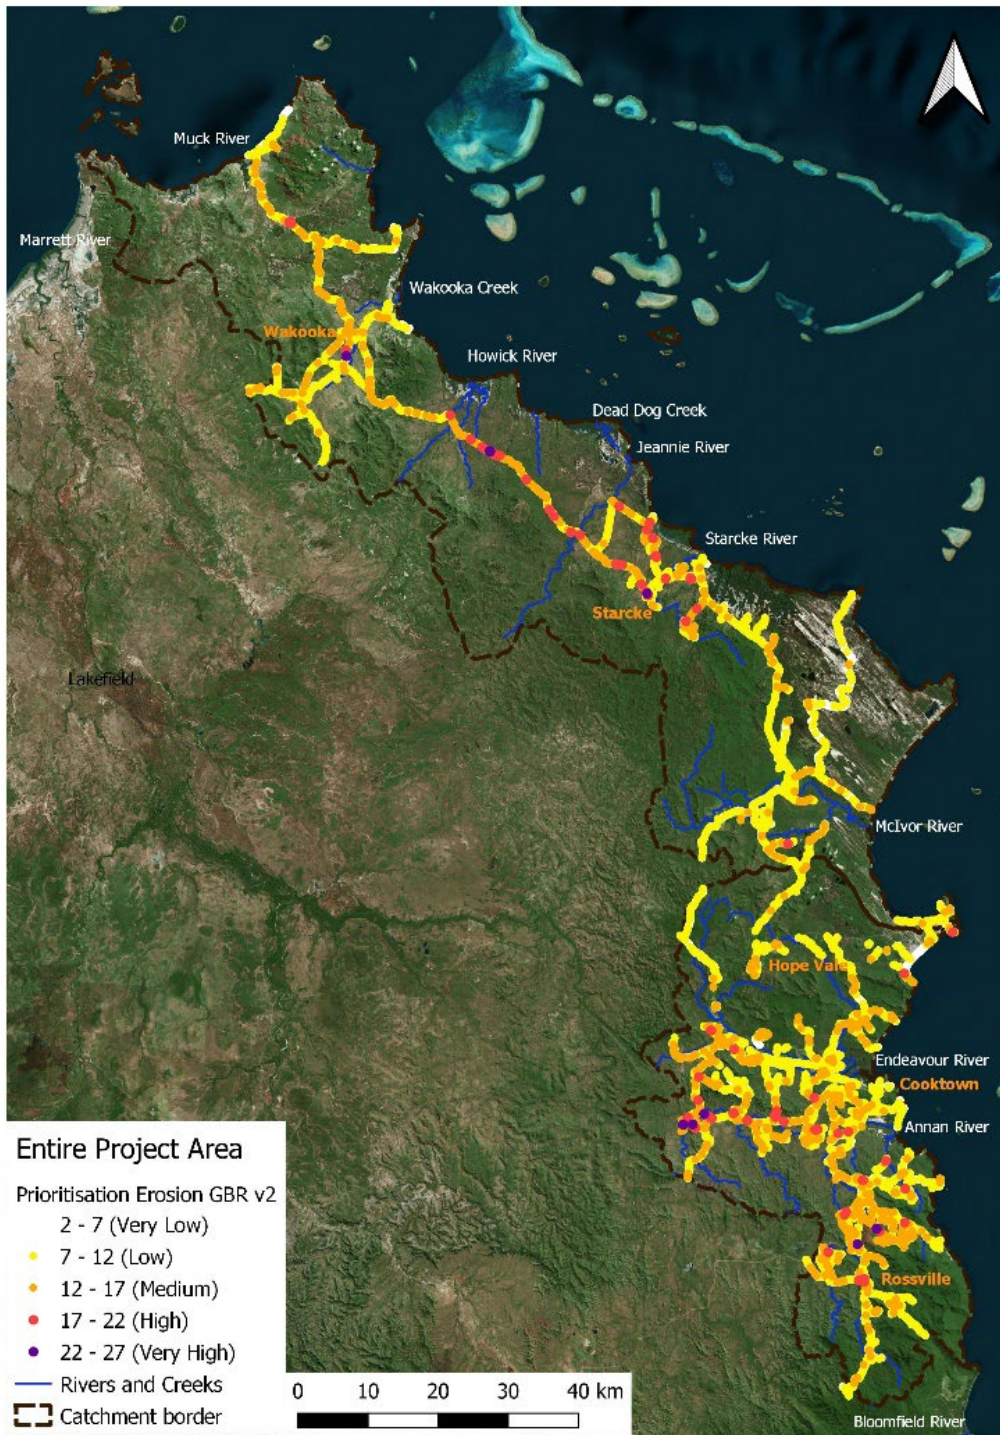
Figure 12 Prioritized erosion hotspots across Eastern Cape York (right) with high connectivity to the GBR.

Out of a total of 232,892 data input points, the erosion prioritisation model ranked 61 sites as Very High Priority and 564 sites as High Priority. All these sites had major rill and gully erosion (Figure 12).

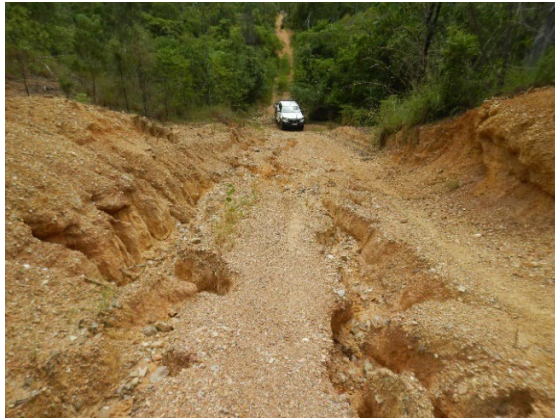
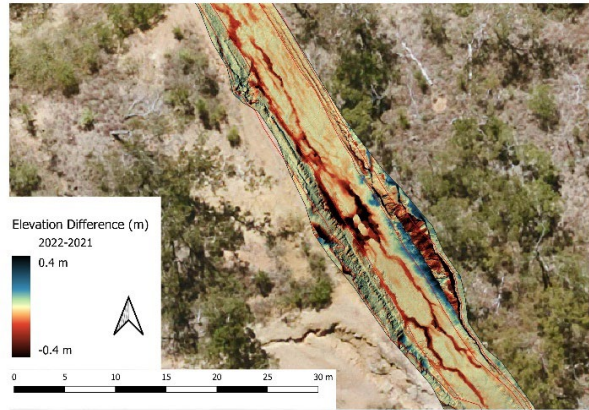
a) 68 kg/m²/yr all sizes locally (18% slope)

or 352 t/ha/yr of fines <20 µm to GBR

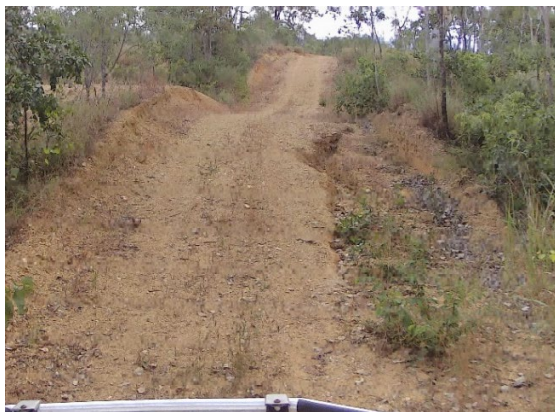
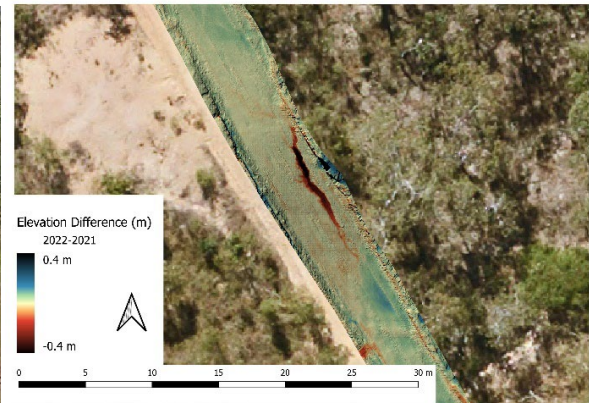
b) 38 kg/m²/yr all sizes locally (13% slope)

or 198 t/ha/yr of fines <20 µm to GBR

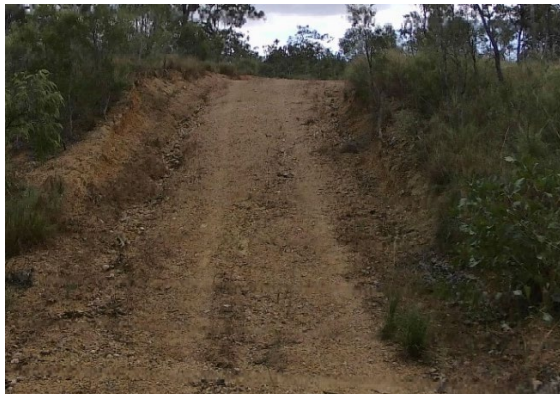
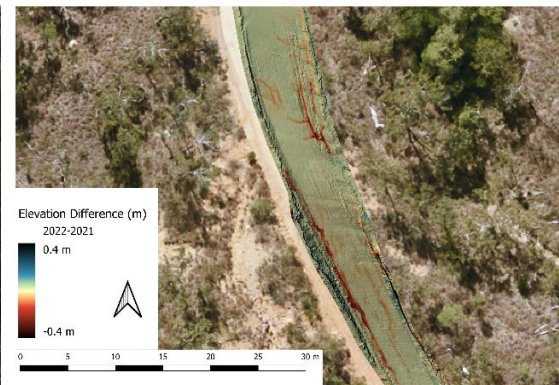
c) 26 kg/m²/yr all sizes locally (12% slope)

or 137 t/ha/yr of fines <20 µm to GBR

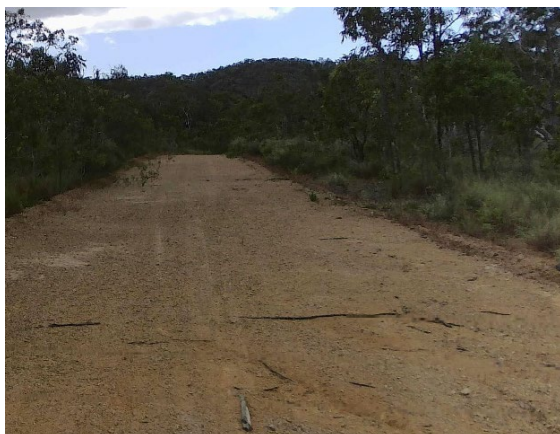
d) 7 kg/m²/yr all sizes locally (3% slope)

or 35 t/ha/yr of fines <20 µm to GBR

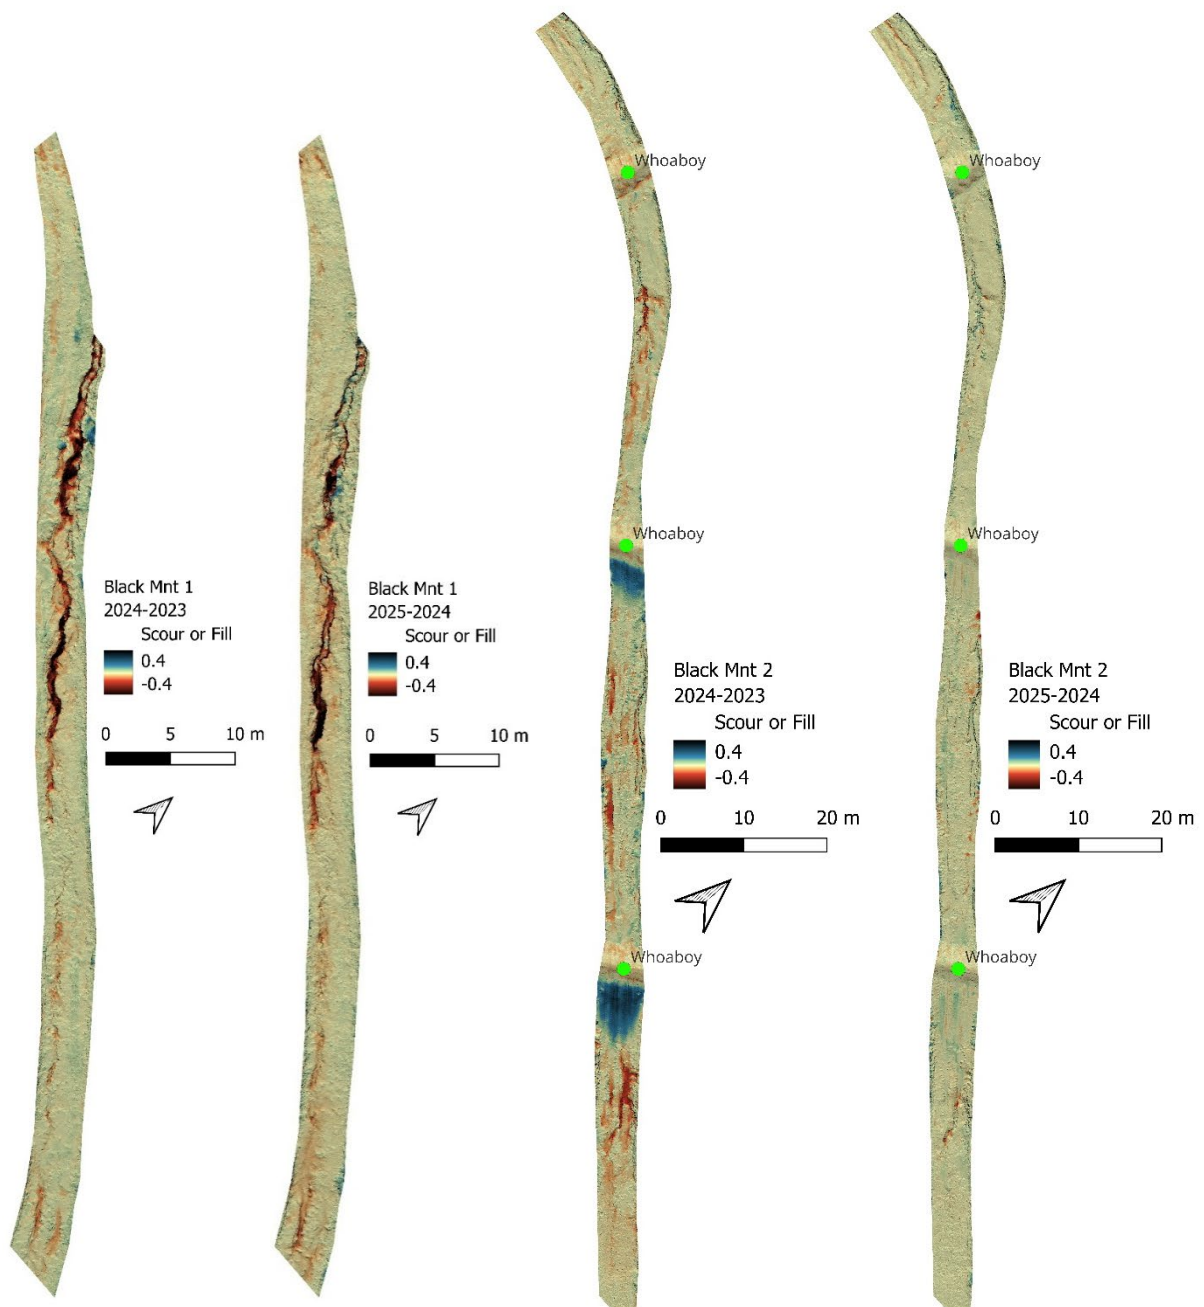
Figure 15 Annual erosion change at Black Mountain track over WY 2024 and WY 2025 (Blk Mnt1 was a control with no treatments, and Blk Mnt2 was treated with whoa-boys both years).

Monitoring using Terrestrial Lase Scanning (TLS) was conducted at a control and treatment segment between 2023-2024 (2900 mm) and in 2024-2025 (1200 mm). The control site had similar erosion rates between years (46 to 50 t/ha/y <20 µm GBR) despite rainfall differences. The whoa-boy treatment site had 72% less erosion the second year (36 to 10 t/ha/y <20 µm GBR) as the project site settled down and regrassed. For just the 2023-2024 period including TC Jasper, the treatment site had 23% less erosion (36 t/ha/y <20 µm GBR) compared to the control site (46 t/ha/y <20 µm GBR). Site treatment cost \$3,215 to install 4 whoa-boys. The cost-effectiveness was \$4,192 t/yr using just the 2023-2024 data comparing control and treatment, or \$8,140 t/y normalised to rainfall average. This higher cost-effectiveness was due to the sandy nature of the soils at this site with 22% fines < 20 µm.

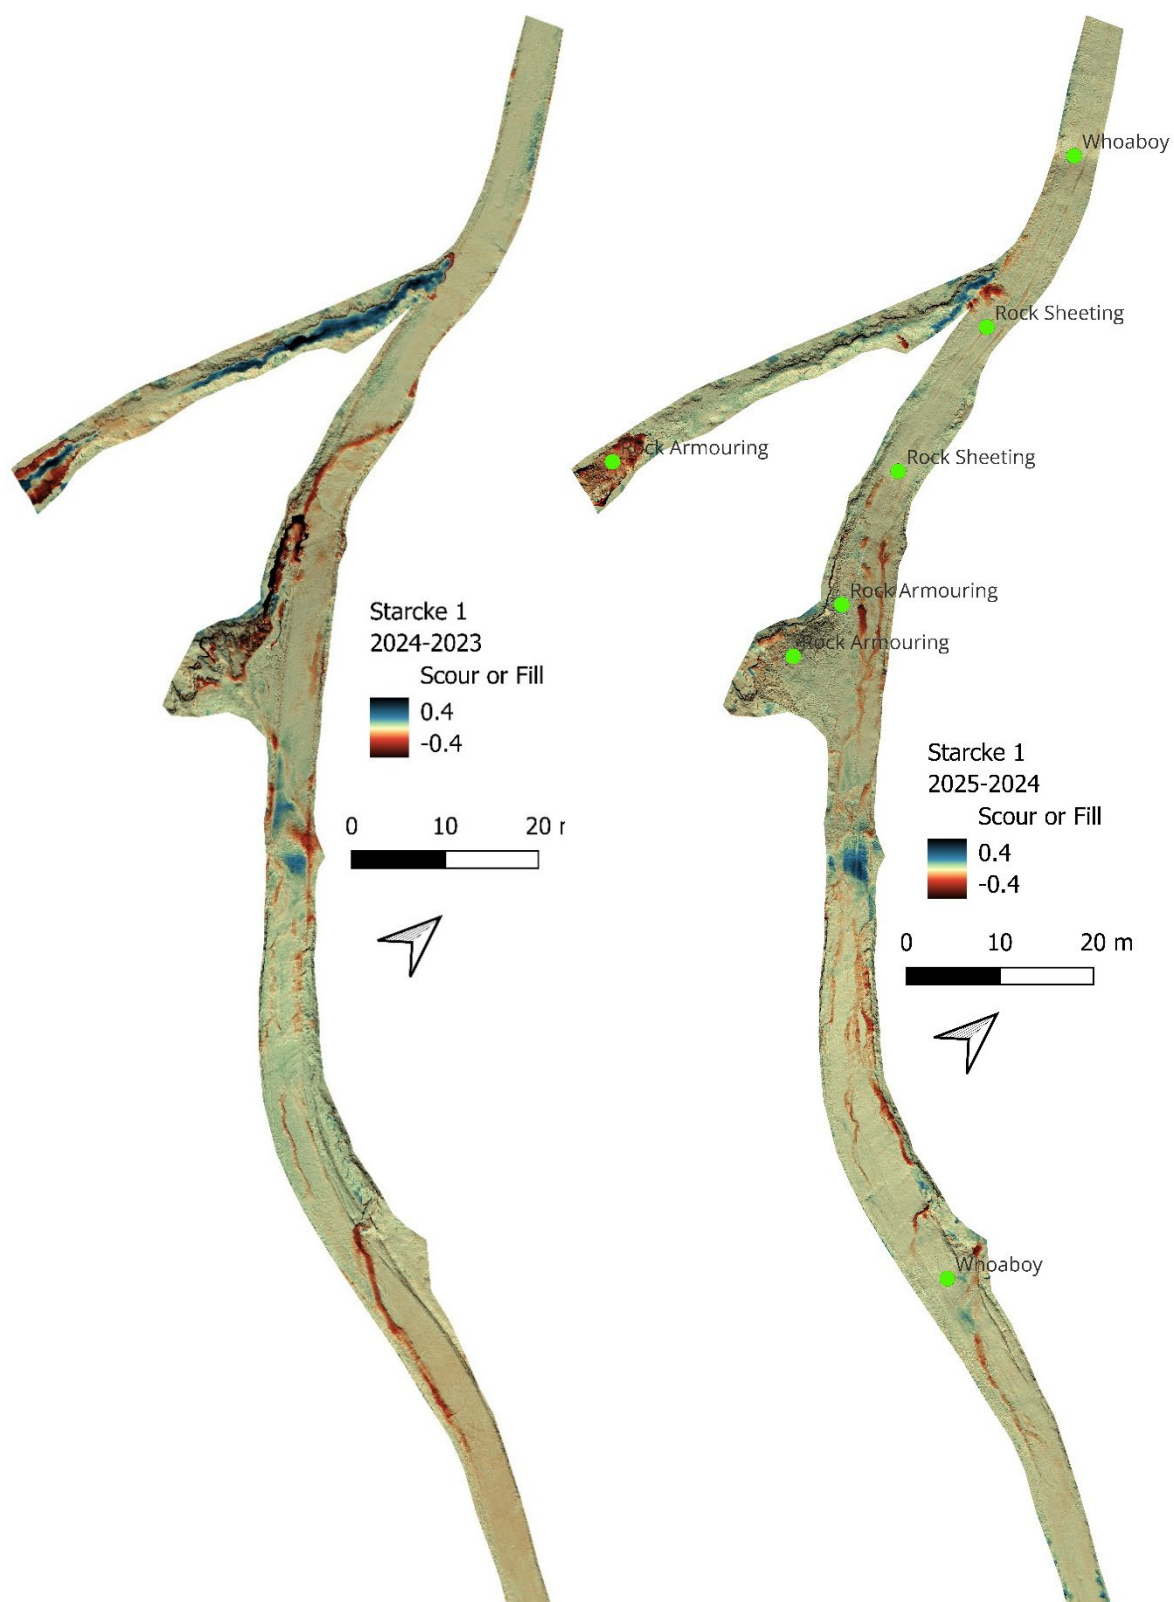
Figure 16 Annual erosion changes at Starcke 1 track over WY 2024 and WY 2025, with treatments occurring in Sept-2024.

At the Munburra Starcke site, erosion rates reduced 45 to 56% at both sites before-after treatment, but rainfall was higher the first year than the second. Normalised to an average rainfall year, erosion rates decreased from 16 to 32% (Table 1; Figure 16; Figure 17). The rainfall-normalised cost-effectiveness was between \$500 to \$1500 t/yr to GBR due to the economies of scale treating many sites with local ridge rock (Table 2). Improved coarse rock armouring of gullies within these sites could have saved even more sediment cost-effectively, via extra time for a sieve bucket to process rock at the pits. Follow up maintenance may be needed.

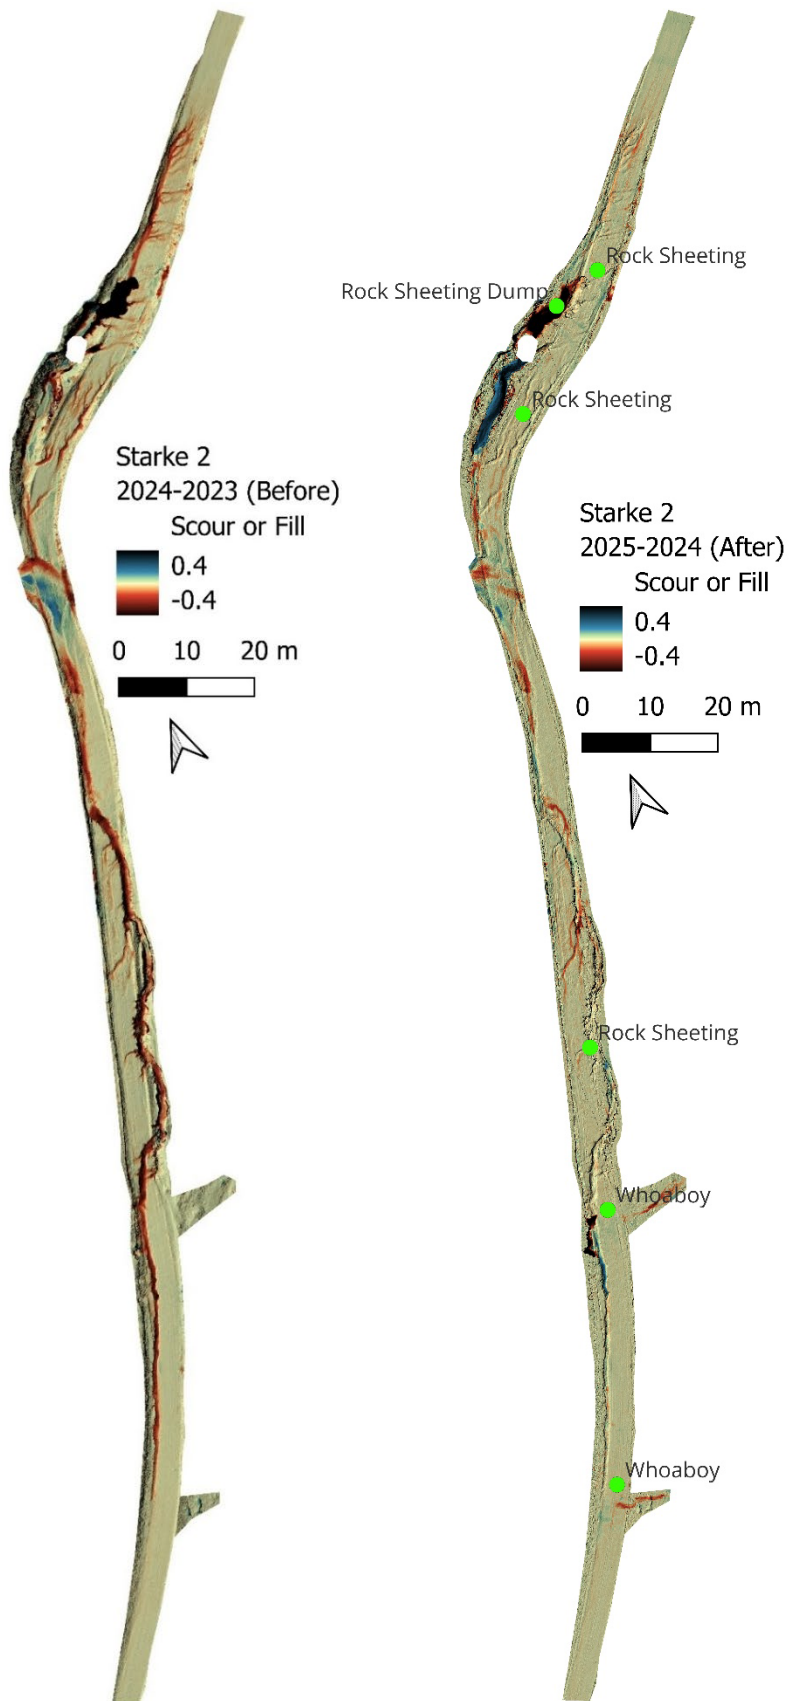
Figure 17 Annual erosion changes at Starcke 2 track over WY 2024 and WY 2025, with treatments occurring in Sept-2024.

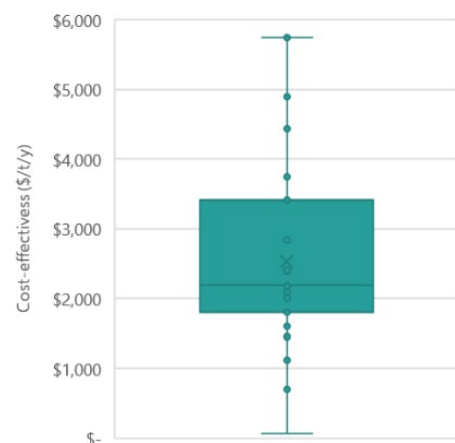
Figure 18 Cost-effectiveness of Reef Trust gully investments in Cape York to reduce fine sediment (< 20 µm) to the GBR (circa 2015-2022, inflated to 2024 dollars, Erlandsen et al. 2024).

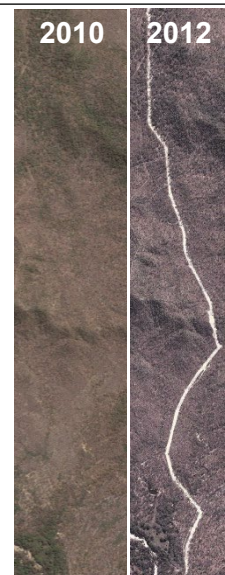
A 500 m road section was surveyed in 2021-2022 with Terrestrial Laser Scanning as a baseline before treatment. Differential surveys measured 33 t/yr of fine sediment < 20 µm to the GBR from a 2615 m² area (12 kg/m²/yr or 126 t/ha/yr < 20 µm) during a below average rainfall year (1476 mm). After erosion treatment with BMPs, differential surveys in 2023-2024 measured 21.6 t/yr of fine sediment < 20 µm to the GBR (8.3 kg/m²/yr or 83 t/ha/yr < 20 µm) during a wet rainfall year (2400 mm including Cyclone Jasper). This was a 34% reduction in erosion even with TC Jasper.

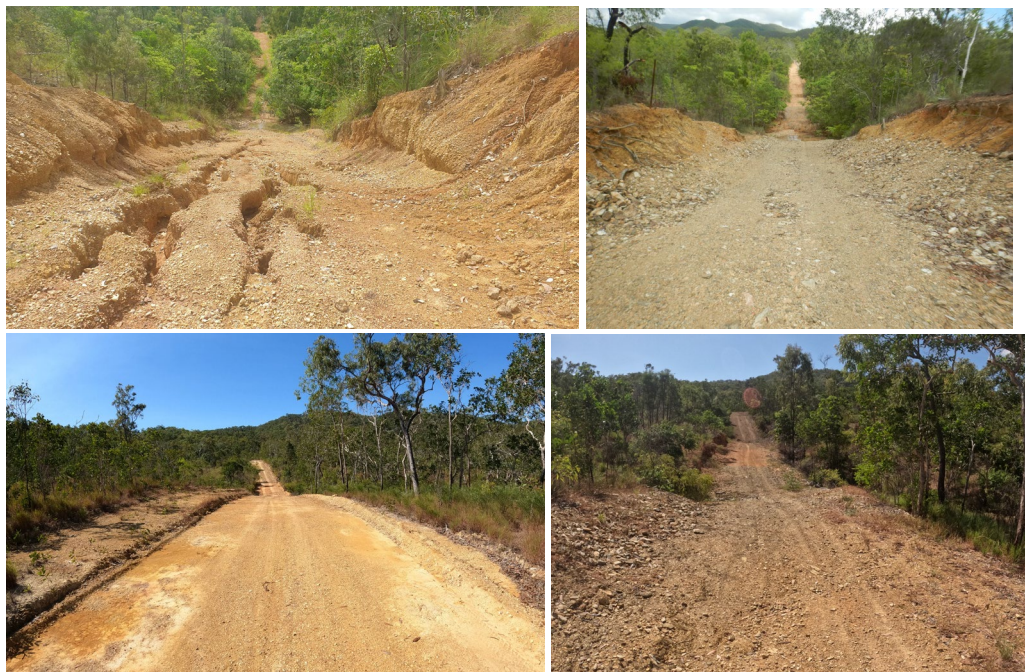
The total cost-effectiveness of the work was \$2,400 t/y during a wet rainfall year and \$1,300 t/y if rates are normalised to an average rainfall year (1600 mm). Installing whoa-boys to divert water was slightly more cost-effective (\$1,240 t/y normalised) than rock sheeting (\$1,336 t/y normalised). However, the whoa-boy section required additional costs and maintenance after TC Jasper and needed to be rock sheeted in patches to maintain long-term access. Rock sheeting steep track sections next to creeks can be essential for long-term access and erosion control.

The Oaky-Flaggy firebreak road (6 km) was bulldozed 15+ m wide by Cook Shire Council circa 2012. It has been repeatedly graded each year without erosion control measures, resulting in significant entrenchment. A 2 km gullied section often blocked property access for weed and fire management. An erosion control project in May 2023 was developed to install BMPs to change annual grading cycles that caused access issues and erosion fine sediment to the GBR.

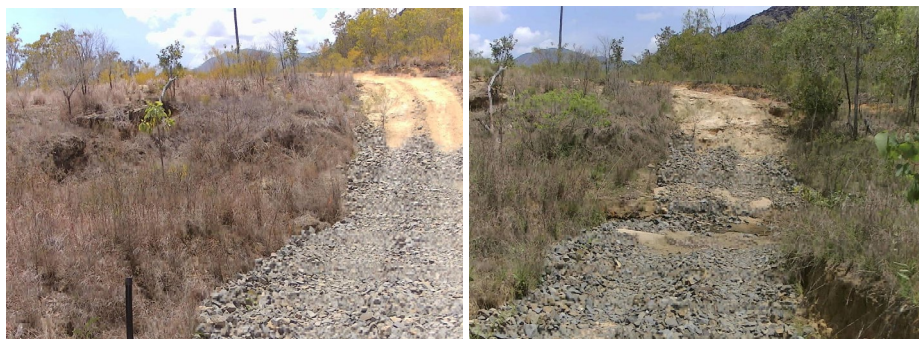
Before-After Cyclone

Cyclone Jasper in December 2023 was a significant test of the treatment works, with 1200 mm of local rainfall in five days. Out of the 46 whoa-boys, only one failed, while five had major erosion and 40 were functionally stable with minor to modest erosion. The creek crossings had more erosion due to the flood impacts, with 19 of the 29 crossings with significant erosion of placed rock. In contrast only a few check dams installed in gullies experienced significant scour. As with many erosion control structures after extreme rainfall, some maintenance will be required for long-term resilience.

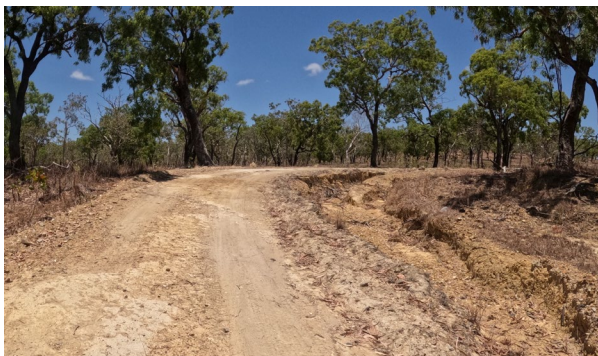
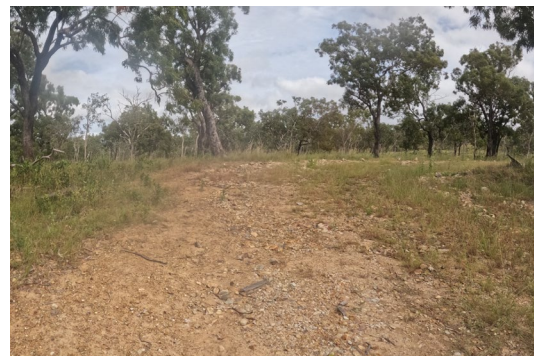
The \$80,000 project was monitored using Terrestrial Laser Scanning (TLS) before and after treatment at two monitoring sites with rill and gully erosion at stream approaches. Erosion rates reduced 45 to 56% at both sites before-after treatment (107 to 58 and 235 to 104 t/ha/y < 20 um to GBR), but rainfall was higher the first year (2196 mm) than the second (1452 mm). Normalised to an average rainfall year, erosion rates decreased from 16 to 32%. The treatment costs for each site varied from \$6,400 to \$7,200 for whoa-boys, rock sheeting, and rock capping gully hotspots. The rainfall-normalised cost-effectiveness was between \$500 to \$1500 t/yr to GBR.

These sites had the benefit of 'economies of scale' where 5000 tonnes of borrow pit material treated 5 km of track. However the extremely rough track and difficulty in hauling water trucks over rough terrain resulted in track 'blowouts' into bull dust where the haul truck traversed patches of silty soil. These patches were capped with additional rock sheeting, increasing costs. In the long-term those vulnerable patches would degrade from erosion and bogging; thus rock sheeting vulnerable sections provided important long-term resilience for access.

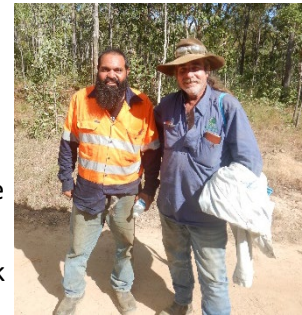
In June 2023, the Jabalbina Yalanji Aboriginal Corporation (JYAC) as principal contractor, additional sub-contractors, and Cape York Water Partnership completed erosion control works along an Ergon Powerline track that also provides key access to JYAC country. The aim was to reduce the fine sediment load entering the Annan River, while also improving track resilience and reducing the annual need to grade and patch the track for access and as a firebreak between JYAC property and Beesbike Station.

Over 25 whoa-boy water diversion banks, 500 m of rock sheeting of stream crossings, and one large rock chute at a gully were completed for a total of \$80,000 inclusive of planning and guidance. The rock chute was designed with underlying geofabric, cut-off wall, and energy dissipation. Following cultural heritage guidance and clearance, 2000 tonnes of rock was extracted from a local ridge quarry (30 m x 30m x 5m deep) at a cost of \$6.84/t. Erosion rates were measured from repeat aerial LiDAR (Ergon data) before the project commenced. Cost-effectiveness was estimated at \$2800/t < 20 um fines saved from the GBR.

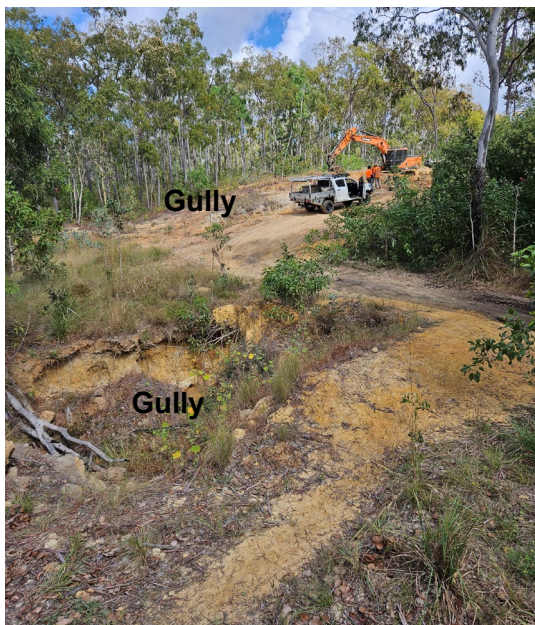
The works have held up well after Cyclone Jasper and > 2700 mm of annual rainfall at the nearby Beesbike gauge. Track management has now shifted from struggling with access and erosion control, to herbicide boom spraying track edges as a firebreak (to early burn later for bare earth) and invasive weed control. This will minimise annual machine disturbance of the soil and track.

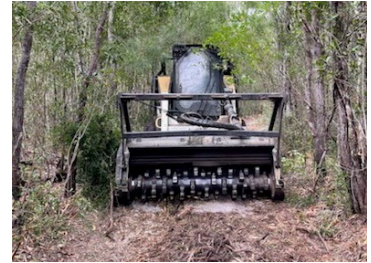
Through on-ground and helicopter surveys in July 2022, Wuthathu Rangers, TOs and invited partners agreed to use a Skid Steer Mulcher for clearing saplings and small trees from tracks to access country. The sandy loose nature of the soils highlighted the importance of root vegetation in holding those soils together. Using a bulldozer, grader or loader to push and dig trees out of the ground would have worsened the erosion and access situation, and not heeded the lessons learned from the gully damages caused to country the last time large machines cleared tracks for mining.

In September 2022, a Skid Steer Mulcher was used along almost 40 km of track from the Ranger Base to the middle Harmer River. Before-after pictures show drivability improvements by November 2023. The maintenance effort has now shifted to ongoing tractor slashing and spot herbicide spraying vegetation regrowth. Additional mulching is planned, along with regulating traffic volumes and speed to minimise the disturbance of sandy soils from vehicle tyres and turning. Gully control efforts have also begun at erosion hotspots preventing sustainable access.

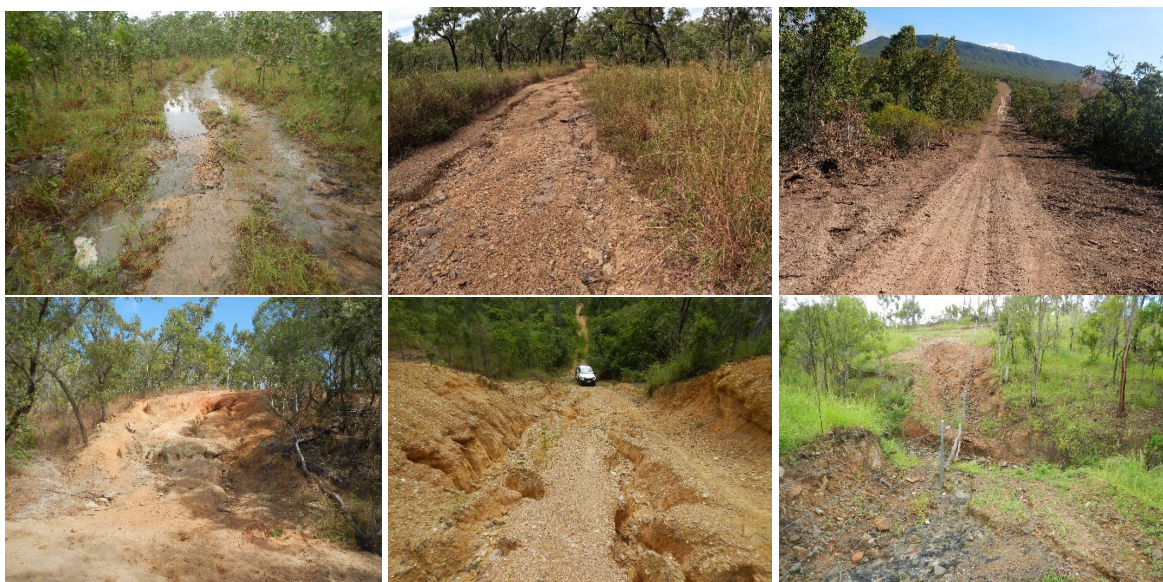
Figure 19 Examples of primitive track erosion issues across eastern CYP.

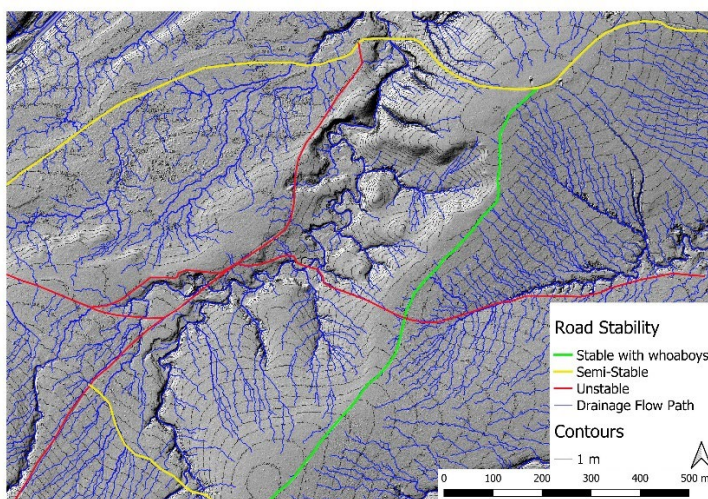
Figure 20 Location examples of track or fenceline stability (stable, semi-stable, unstable) (above).

- Locate roads and fencelines on stable soils and geology.
- Follow subtle ridge and spur crests between drainage catchments.
- Avoid creating roads through or along hollows, gullies, creeks, rivers and frontage country with dispersive soils.
- Adjust line accordingly to avoid erosion hazards, especially gully prone areas, steep slopes, and sodic or dispersive soils.
- Keep back from hollow or terrace edges where gullies can form.
- Scout and map the best routes far ahead of time. Use available technology such as GPS, topographic maps, Google Earth satellite images, and LiDAR topography.
- Local non-profit organisations are available to help with new mapping tools.
- Include erosion control BMPs as part of primitive road construction.
- Map out where erosion control BMPs will be installed.

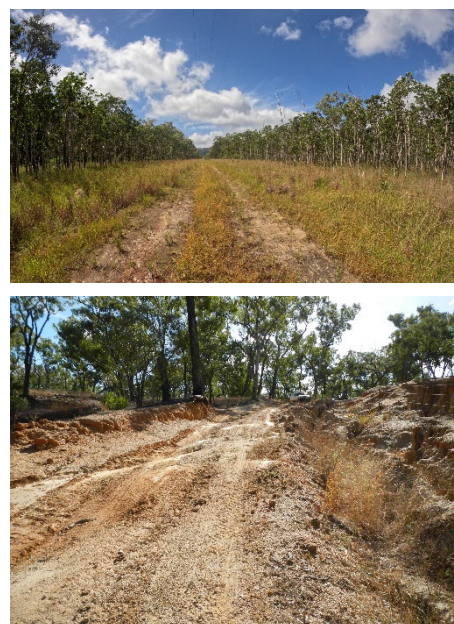
Figure 21 Primitive road locations on A) a stable ridge track with good grass cover and low maintenance (right above) and B) an unstable alluvial slope with chronic erosion along a fenceline track (right below).

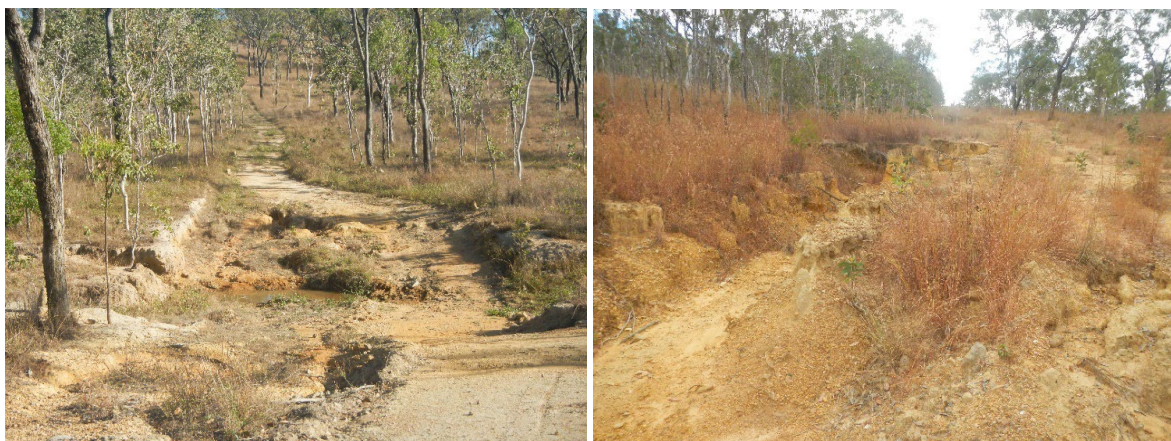
Figure 22 Typical eroded stream crossings and approaches along primitive tracks.

- Minimise the number of road crossings through hollows, gullies, and creeks.
- Choose a key stable crossing, rather than creating multiple crossings.
- If a crossing is required, scout and locate the most stable locations with lowest slopes, rocky bars, and least need for road cuts at approaches.
- Apply erosion control BMPs to key stream crossings (see below).
 - Avoid road cut entrenchment and frequent grading of approaches.
 - Install whoa-boys to divert water runoff early along flow paths to prevent concentrated flow at steeper approaches.
 - Avoid diverting water into gullies, toward creek/river banks, or into hollows susceptible to gullying
 - Rock sheet the approaches to creek crossings and dispersive soil areas.
 - Rock armour creek and gully bed crossings where unstable or blown out.
- Planned and constructed creek crossings will maintain long-term track accessibility.

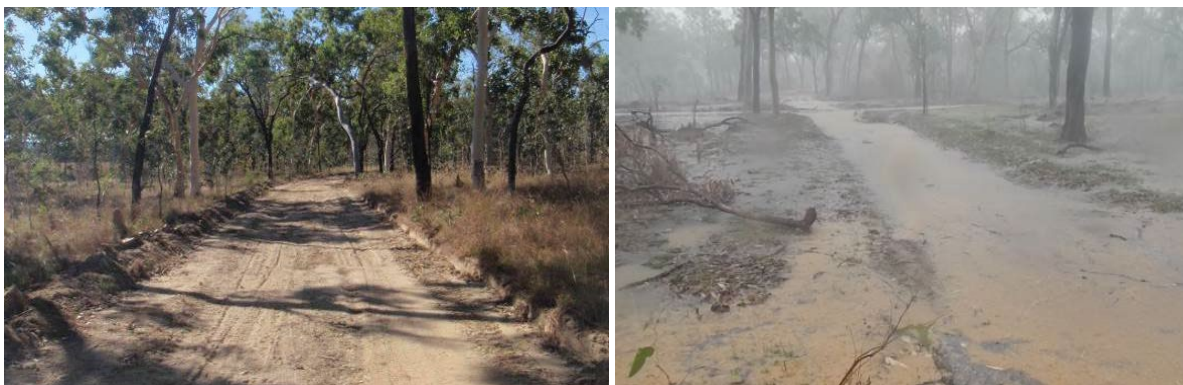
Figure 23 Grading the road down each year creates entrenchment and erosion.

Track degradation from rill and gully formation is often caused by graded tracks that collect and concentrate water flow. Over-grading and annual grading will result in entrenched tracks with poor drainage, especially in silty or dispersive soils. Even under the best of intentions of lightly grading the grass off a track, entrenchment will result from repetitive annual light grading. Attempts at road formation (prism and drains) in silty or dispersive soils on primitive tracks often makes the situation worse. Silty topsoils are not stable or cohesive, and exposure of dispersive sub-soils promotes rill and gully erosion. Cutting drains into dispersive soils causes gully erosion on and off the track. Tracks should be kept vegetated and well drained naturally, or with whoa-boy diversion banks and imported rock sheeting in low places.

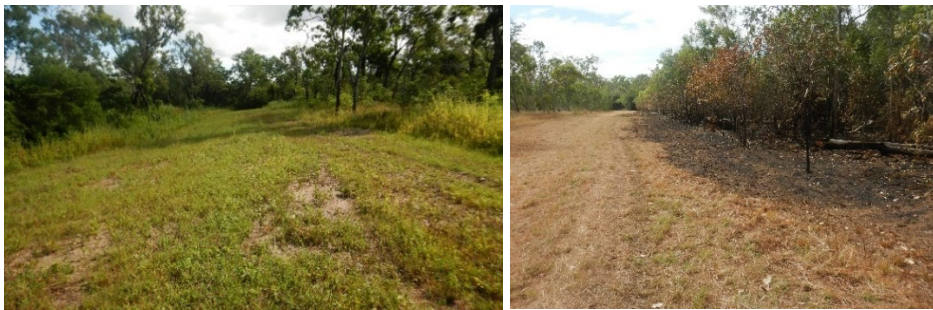
Figure 24 Slash or mow tracks, fencelines and firebreaks (for later burning if needed).

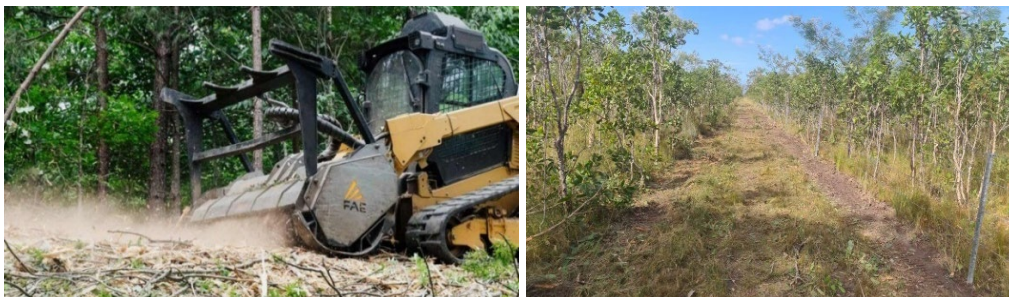
Figure 25 Use skid steer mulchers for clearing saplings and small trees from fences and firebreaks.

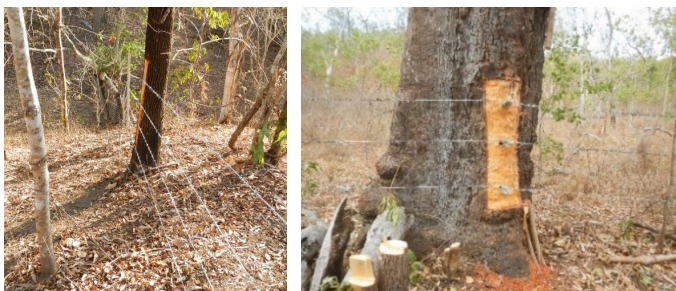
Figure 26 Fencing tree-to-tree over steep banks to reduce erosion and soil disturbance.

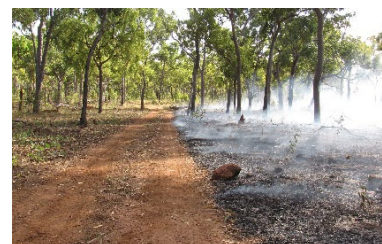
Figure 27 Two-wheel track firebreak with prescribed burning with water and blower support.

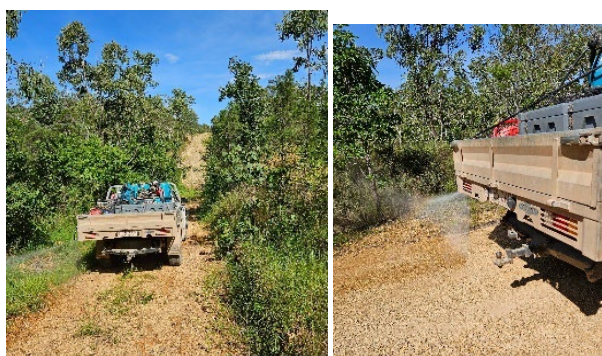
Figure 29 Herbicide chemical boom spraying firebreaks.
