Erosion along Unformed Roads, Tracks, Firebreaks and Fencelines in Eastern Cape York Peninsula and Best Management Practices (BMPs) for Erosion Control

Produced by
Cape York Water Partnership (CYWP)

Shellberg, J., Albert-Mitchell, O., Klye, D., Smith, B., 2024. *Erosion along Unformed Roads, Tracks, Firebreaks and Fencelines in Eastern Cape York Peninsula and Best Management Practices (BMPs) for Erosion Control, Version 1.3*. Produced by the Cape York Water Partnership (CYWP) with funding from the Great Barrier Reef Foundation (GBRF) & Reef Trust Partnership (RTP). <https://www.capeyorkwaterpartnership.org/>

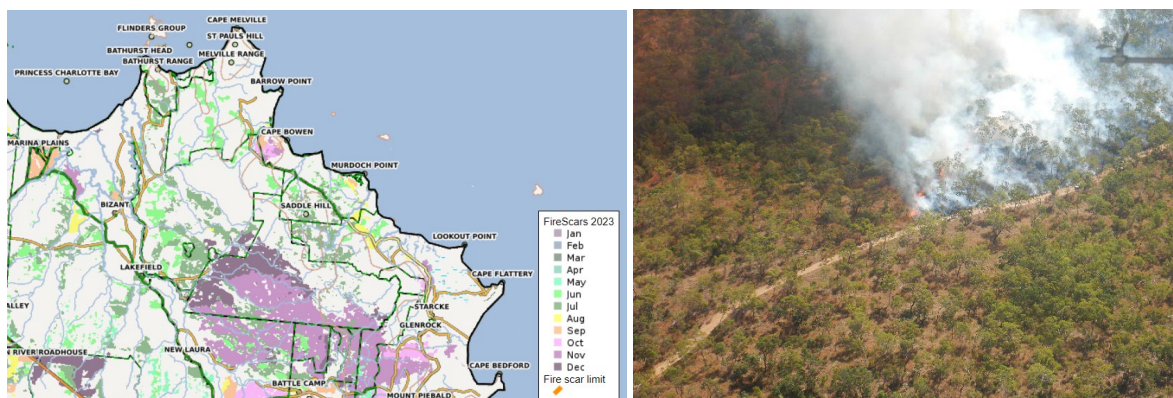
Figure 30 Early-dry (green) and late-dry (purple) season burnt mosaics (left) and connecting burns using track access (right).

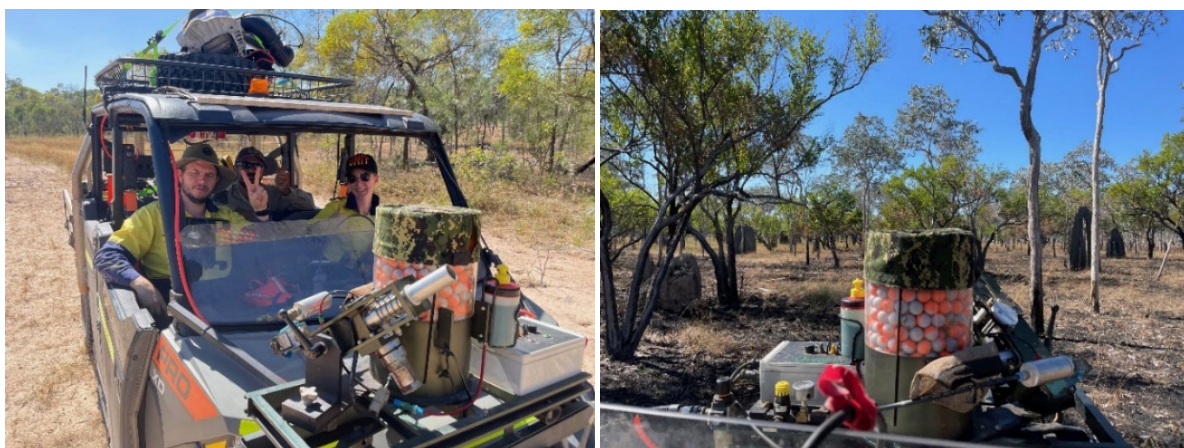
Figure 31 Prescribed fire lighting unit that can shoot incendiary balls 50 m from tracks to create effective firebreaks and rotate the location of annual burning (courtesy of Tropical Fire Technologies, Darryl Killin).

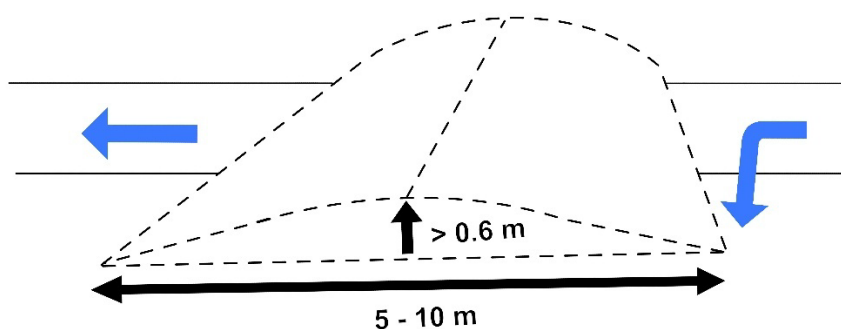
Figure 32 Dimensions of water diversion banks (whoa-boys) used frequently to divert water off roads.

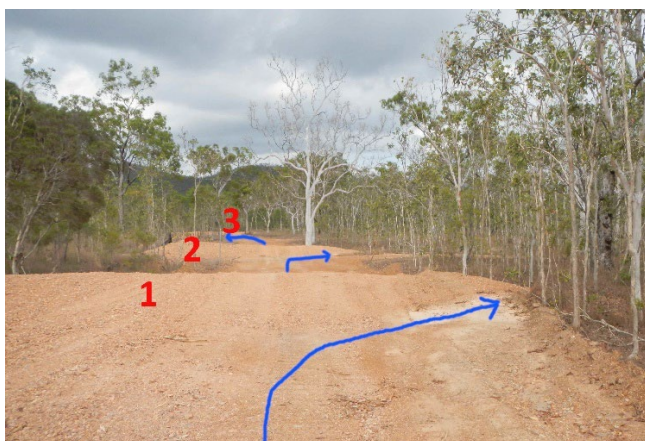
Figure 33 Flow paths and whoa-boy water diversion directions along a primitive track (left and right).

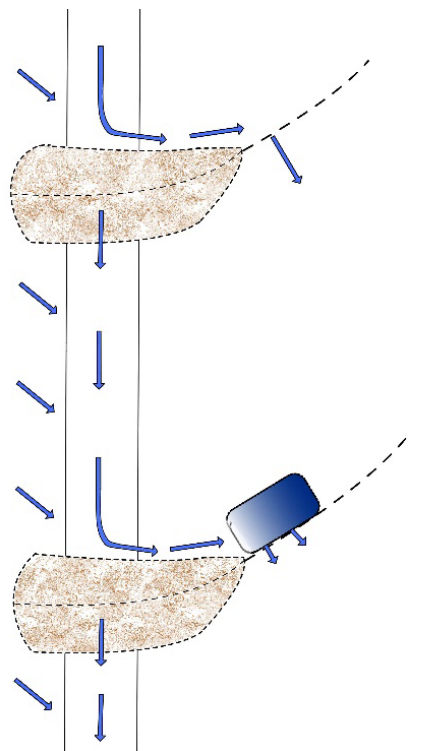
Table 3 Recommended water diversion bank spacing (m) on highly erodible.

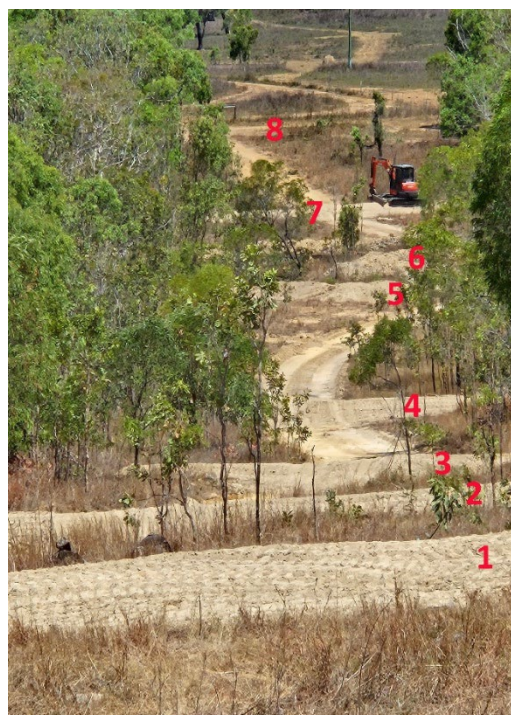
Figure 34 Example of water diversion banks (whoa-boys) sequentially installed every 30 m on a primitive track using local gravel/soil from ridgeline borrow pits.

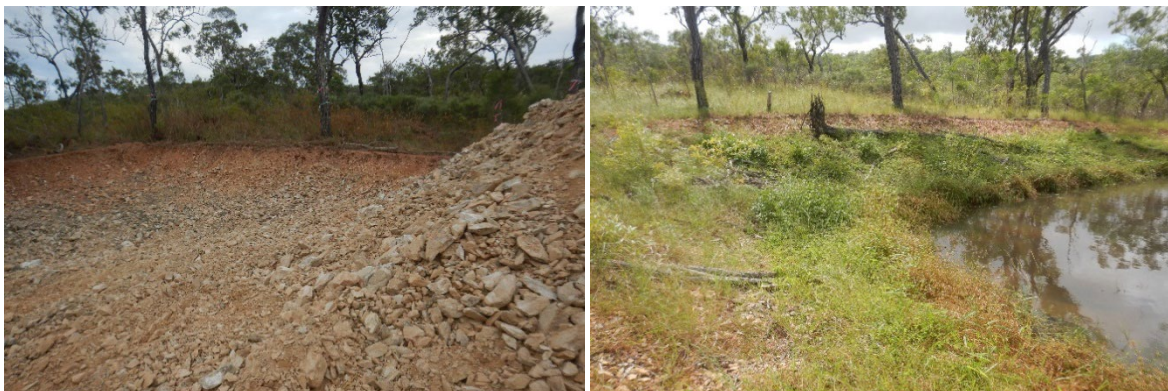
Figure 35 Source rock from local borrow pits on stable bedrock ridges (minimise area to 20 m x 20 m) and rehabilitate area after completion including any drainage erosion control.

- Minimise distances of hauling local rock where possible by accessing more frequent local borrow pits,
 - Minimise track damage by haul trucks, which can require rock sheeting.

- Adapt to local conditions and material availability where needed.
 - On floodplain areas with dispersive soils, it will be impractical to import ridge gravel from far away due to haul damage to tracks.

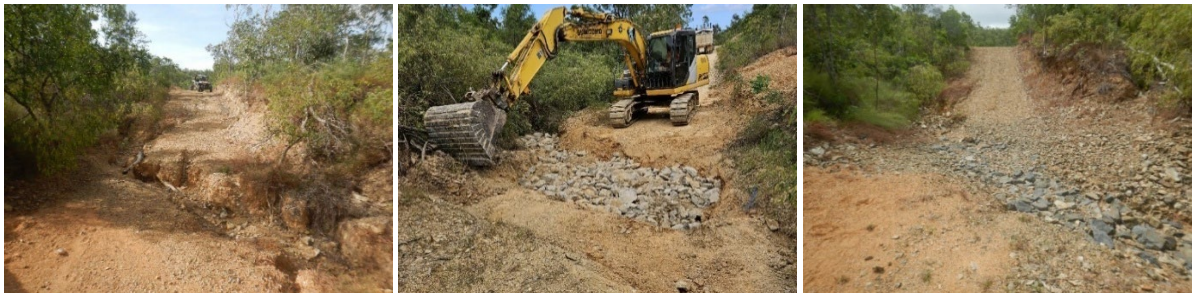
Figure 36 Before, During and After rock armouring of a gullied stream crossing.

Steep road sections at creek crossing approaches or on hillslopes are inherently unstable, due to increased energy of water flow. Washouts near creek crossings are extremely common (gully erosion hotspots). Annual quick fixes to fill them in and gain access perpetuates a cycle of erosion and land degradation. Rock armoring crossings and rock sheeting steep approaches increases their resistance to erosion. Dispersive sub-soils on less steep country can also be unstable or boggy and need rock sheeting. Investments in rock sheeting and armoring can save time and money in the long-run and sustain longer seasonal access for other land management purposes.

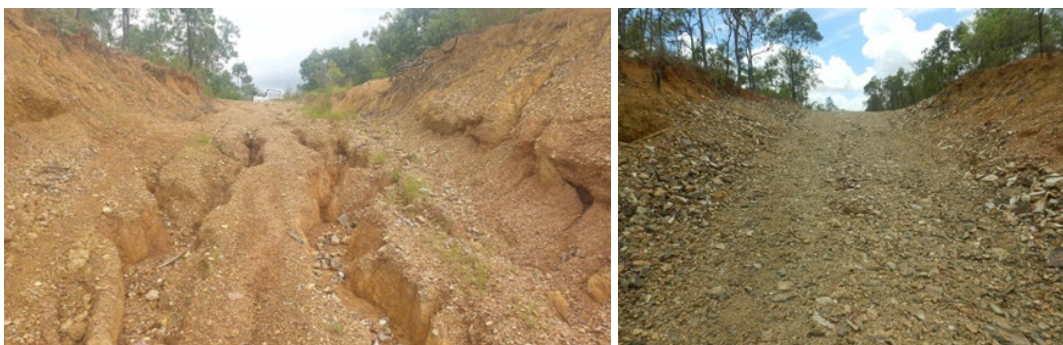
Figure 37 Before/After rock sheeting of a gullied road cut approaching a stream crossing.

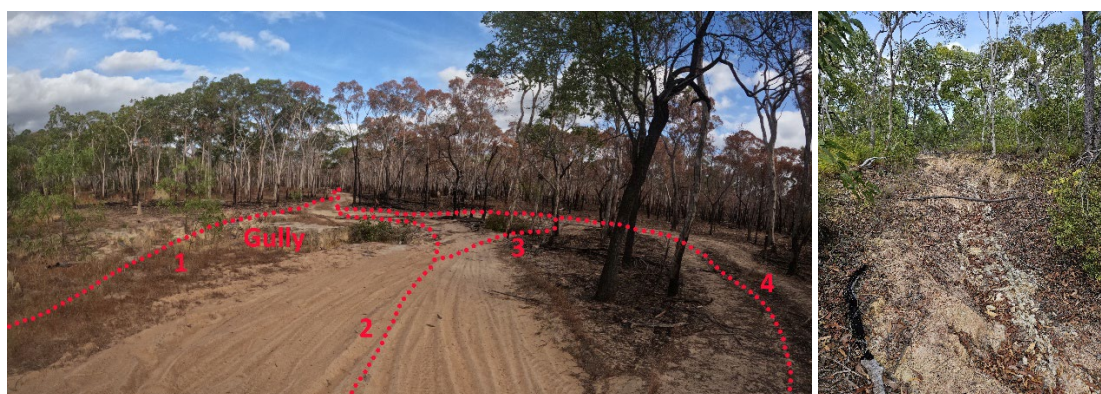
Figure 38 Track locations over 8 years avoiding a gully created by the track (above left). Abandoned track still eroding and unvegetated after many years (above right).

Erosion hotspots such as gullies or washouts are the result of another source problem, such as excess water runoff down a track, road cuts and grading disturbance, catchment management (fire, grazing), or poor landscape planning. When new tracks are re-routed around gully hotspots created by the track, a cycle of land degradation is created. Legacy erosion issues become worse and more costly to remediate over time, or can require frequent management intervention.

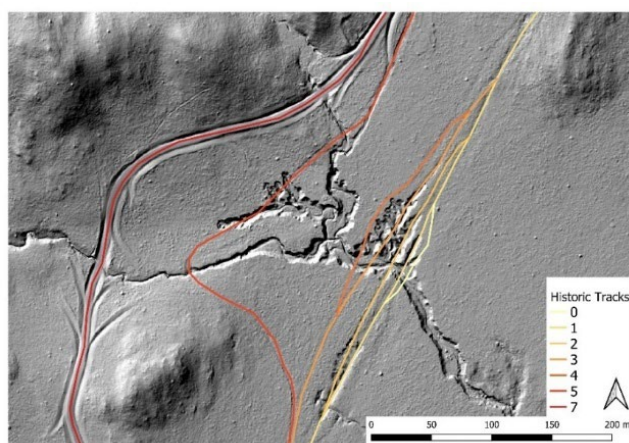
Figure 39 Changes in historic track locations to route around gullies caused by the tracks.

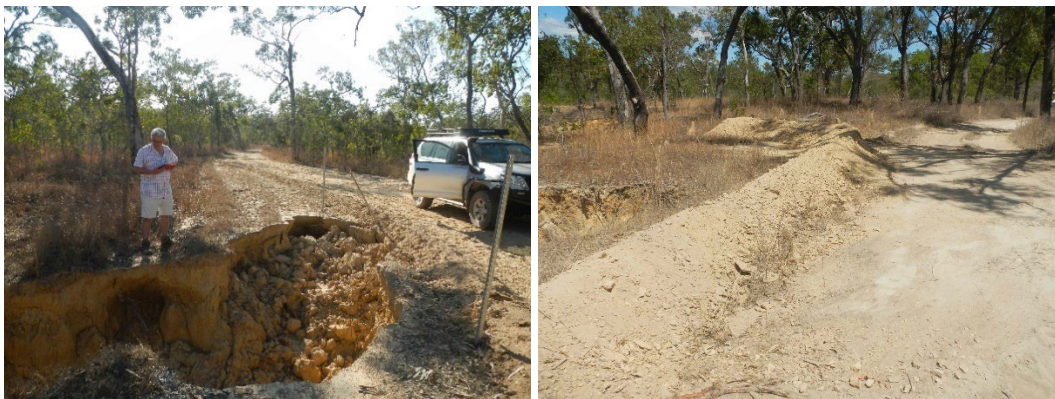
Figure 40 Divert water flow away from gully heads using water diversion banks (ridge gravel).

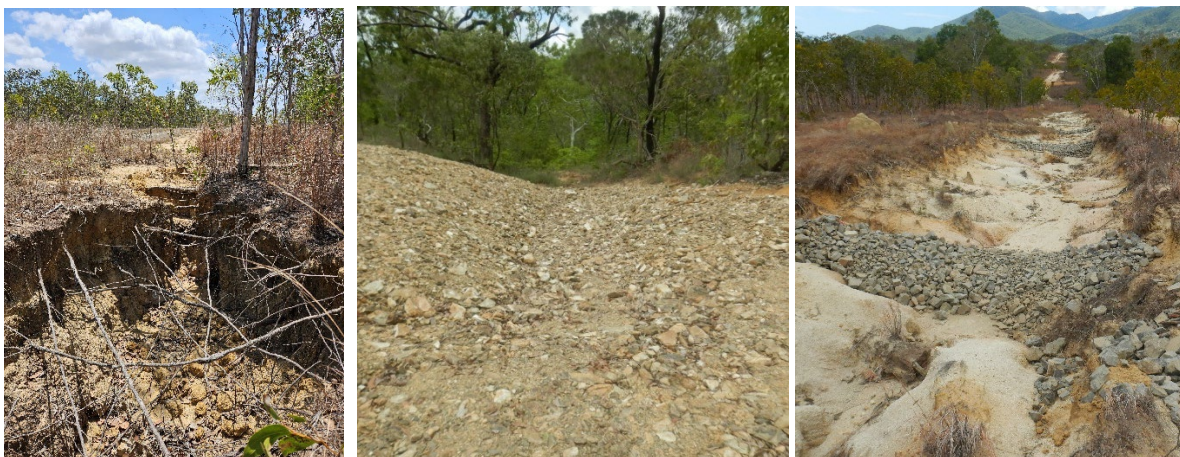
Figure 41 Road gully at a drain outlet (left) addressed with a rock chute (middle) to control flow energy. Check dams installed in an old track and gully (right).

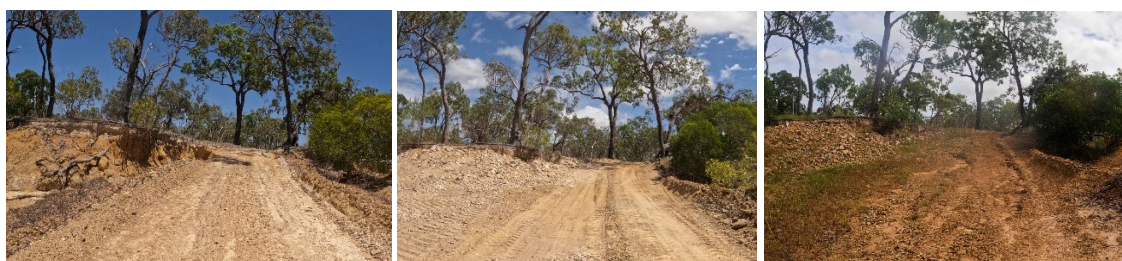
Figure 42 Surveying erosion control measures before (left, 2023) and just after (middle, 2024) and a year later (right, 2025).

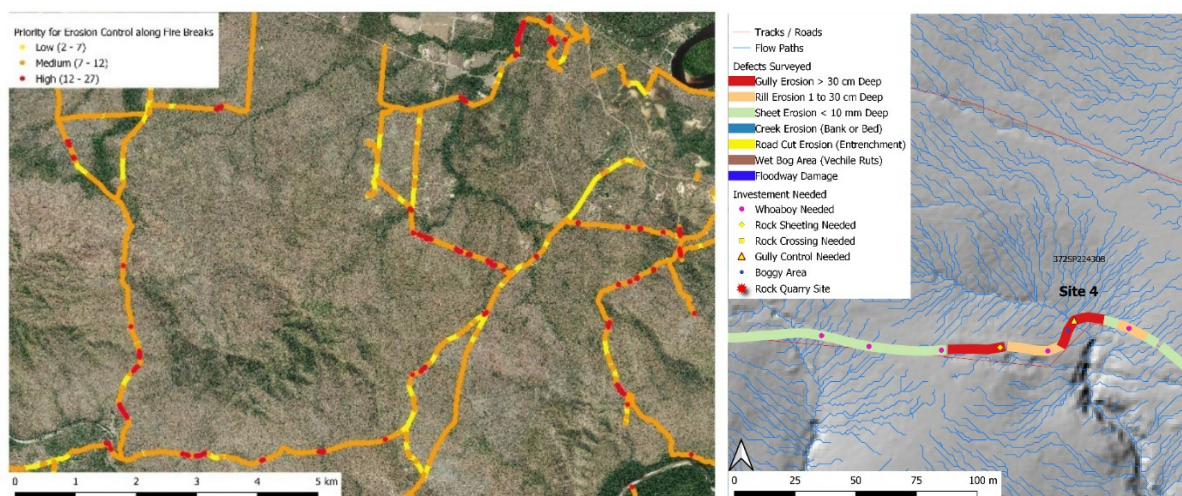
Figure 43 Priority mapping for erosion control along tracks and firebreaks.
